WHEN FLOOR RESTORATION IS THE ONLY OPTION

ASHTON'S 5-STEP PROCESS TO LEVELING AND REMOVING YEARS OF CHEMICAL SPILL STAINS

BACKGROUND

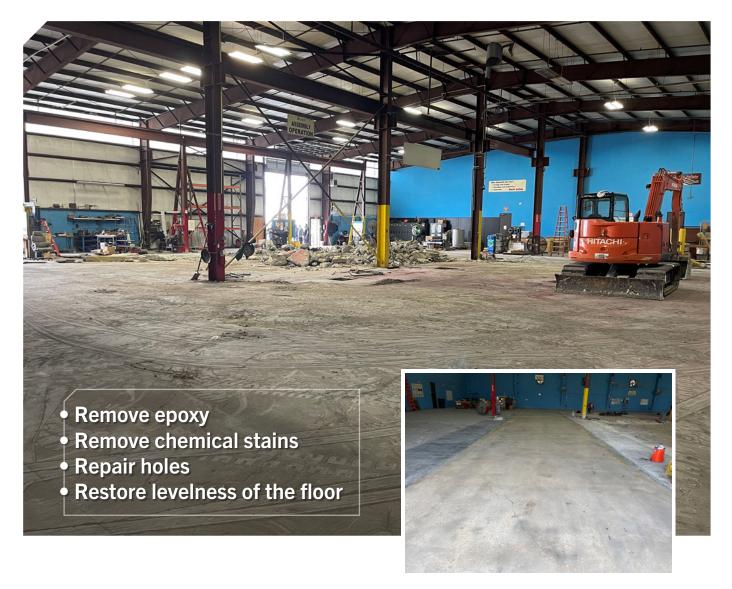
Tranter Manufacturing's chemical storage plant in Houston, TX was put on the market and desperately needed floor restoration. The existing 6,000 sq ft concrete warehouse was coated with 20-year-old Epoxy that had experienced years of damage from chemical spills.

To complete the sale of the plant the concrete needed to be restored to its original condition in 1 weeks' time. Restoring the concrete would require:

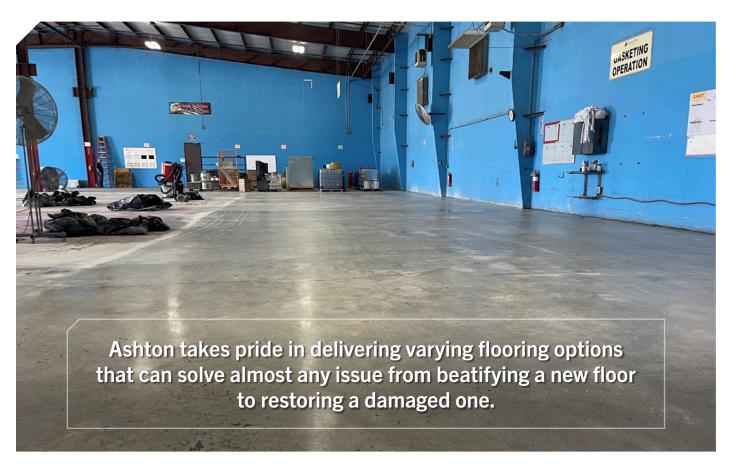
In the case of Tranter Manufacturing's chemical storage plant, Ashton knew the floor needed a lot of upfront work to remove evidence of extensive wear and tear before the final polish and seal could take place.
